ENGINEER'S REPORT

MEEKER COUNTY DITCH 47 / MIDDLE FORK CROW RIVER RESTORATION PROJECT #2017-01

Engineer's Report

July 2017

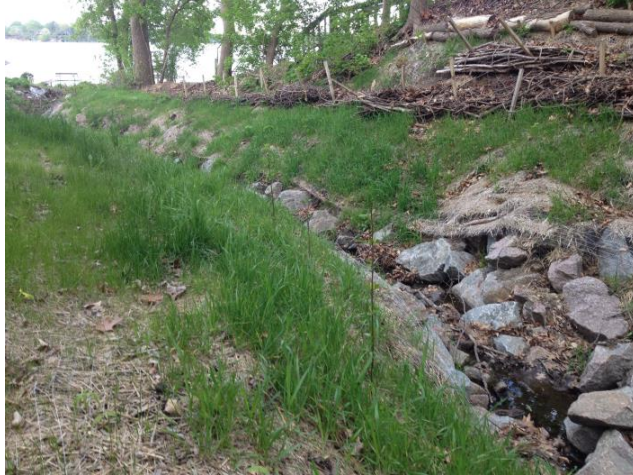
Vegetated riprap is intended to provide toe protection on taller (> 4'), vertical, eroding stream banks. Riprap would be installed at the existing toe line of the side slopes and be keyed in slightly below the stream bed. Some bank disturbance would be required to make the vertical bank less steep (ideally, 2:1 H:V or less) by grading from the top of the bank to the new riprap toe. Final stabilization of the riprap toe areas would include revegetation with native seed and either erosion control blanket along the channel where high flows are expected and straw mulch or hydro-mulch in the upland areas. Riprap toe would follow the existing bank, would balance cut and fill on site and would not alter the channel cross section.

Description. Vegetated Riprap Channel, 1 year after construction.

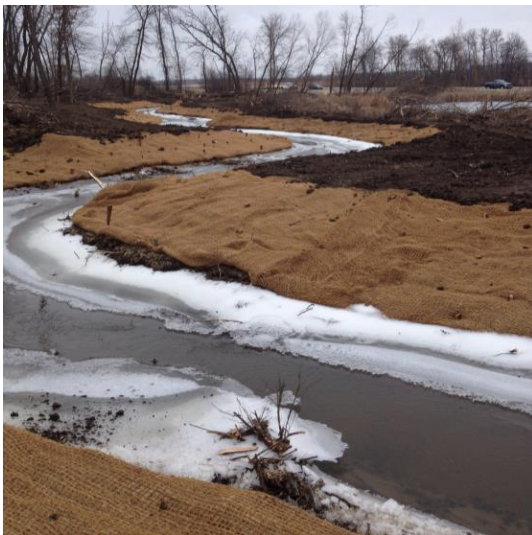
Bank resloping is a bioengineering stabilization technique to be used in instances where flow velocity allows (<6 FPS) and/or for the portions of the bank above the normal high water level of a channel. Bank resloping is intended to establish native vegetation and provide toe protection on shorter (<3'), steep stream banks. Resloping the bank ranges from 3:1(H:V) or less (preferred), to no steeper than 2:1. It is intended to provide a stable slope for new vegetation to establish. The roots of the vegetation hold the slope during periods of inundation and reduce soil migration.

Description. Resloped Banks Constructed During Winter Work on Elm Creek.

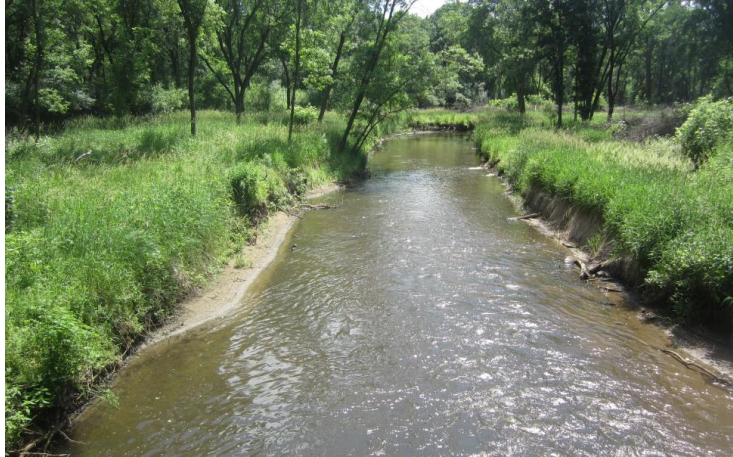
Thinning existing trees to presettlement vegetation densities of 5 – 10 trees per acres, allows for more sunlight to reach the soil. Increased sunlight encourages the amount and vigor of ground plane grasses thus mitigating soil movement into adjacent waterbody's.

Description. One year after clearing trees, the existing seed bank grew into a healthy grass buffer on Coon Creek

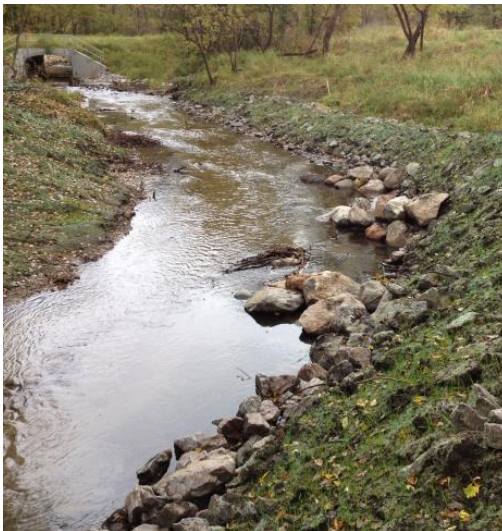
Stream barbs are a descending trapezoidal mass of rock, pointed upstream extending from the center of the channel back into the adjacent bank. Stream barbs serve to redirect erosive force within the stream channel back toward the center of the channel and away from the banks. On the downstream side, at approximately 5 times the length of the barb, water flow experiences reduced velocity and erosive action allowing sedimentation to occur.

Description. Three stream barbs to turn the flow of Purgatory Creek away from sharp outside bend.

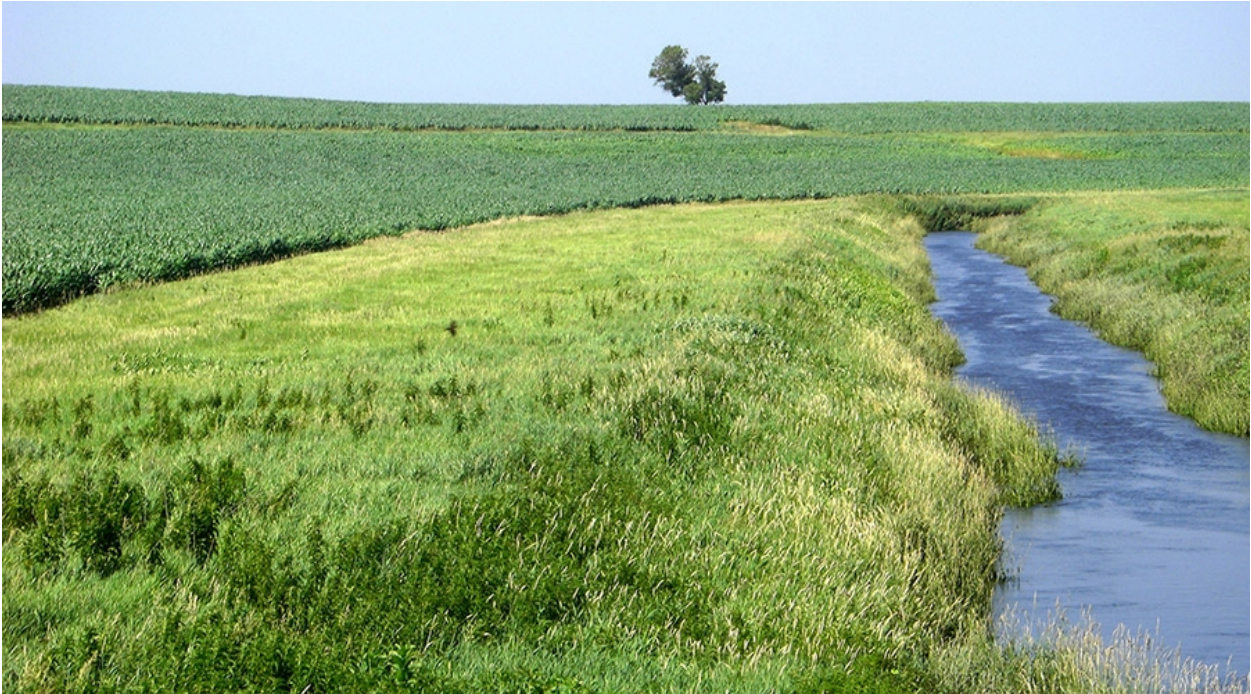
1 rod = 16.5 ft. Buffers stabilize the ground surface near waterways from overland flow, as well as, filter sediments out of stormwater runoff from surrounding areas by reducing flow velocity. Bare farm fields and paved surfaces in particular can contribute sediment into adjacent waterways. Implementation of the new MN Buffer Law will help stabilize the banks and improve water quality and habitat of the Middle Fork Crow River.

Description. An established grassed buffer. Photo by MN DNR.

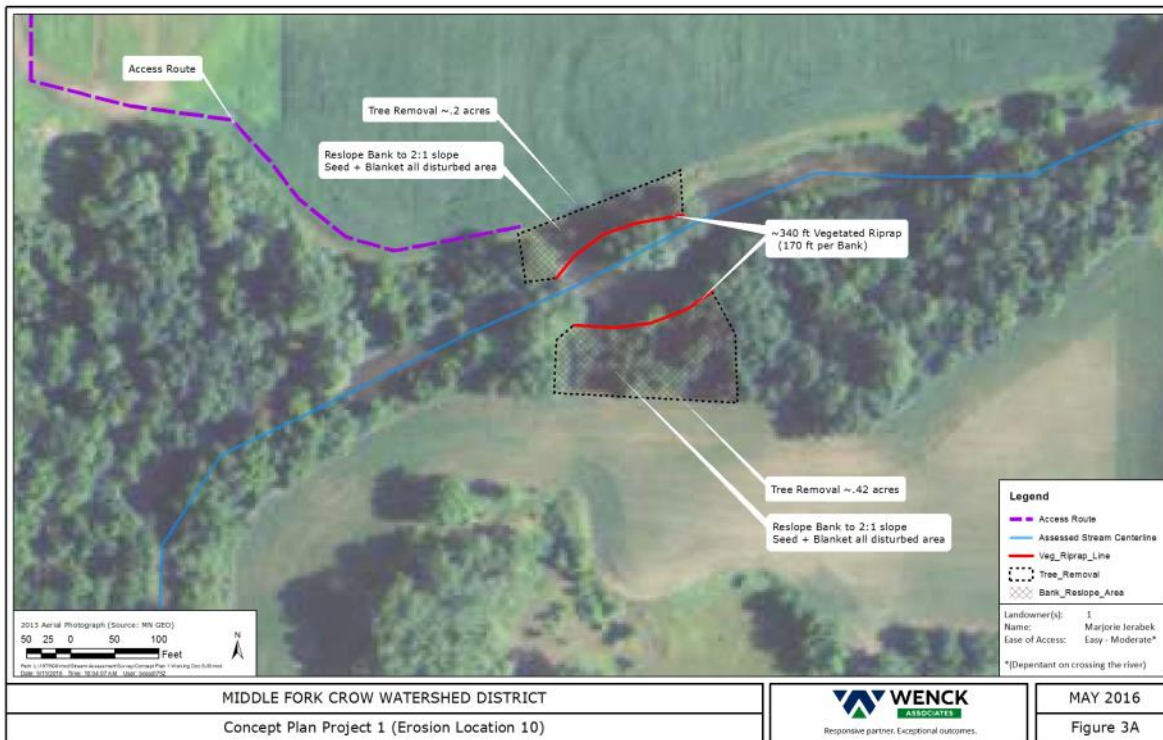
PROJECT AREA 1: TOE PROTECTION WITH VEGETATED RIPRAP

At Project Area 1, river banks are severely eroding for approximately 170 ft. on both sides and have an eroded vertical face of 4 ft. The erosion is due to do a bridge located directly upstream that creates a restriction in flow, a hydraulic jump and circulating eddies coming off the downstream flow onto the embankments. To minimize the current scour, collapse and erosion, both banks will need the toe protected in with vegetated riprap and regraded to a slope of 2:1 (3:1 if possible). In order to accomplish the regrading and allow sunlight to penetrate the new grade trees will need to be removed directly upslope from the affected area.

Project Area 1 would require 0.8 acres for temporary construction easement assuming a 15ft width easement.

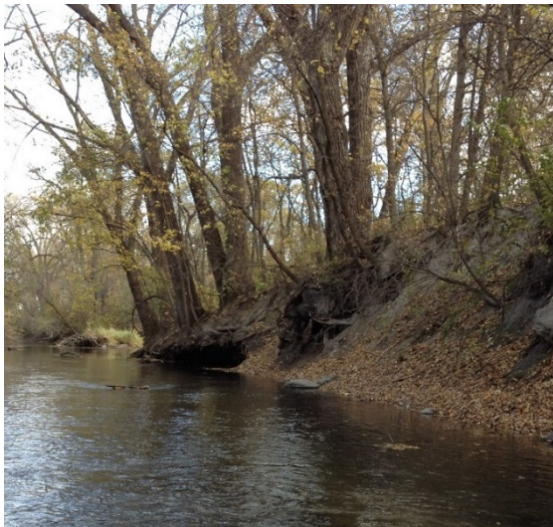
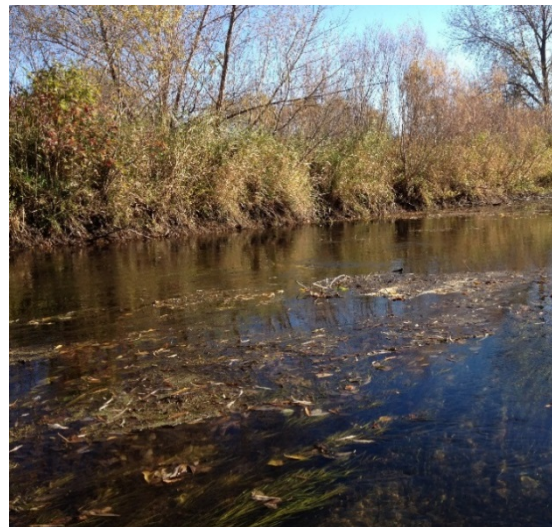
Lack of groundcover vegetation and eroding banks on Project Area 3 (on right). Downstream reach with less tree canopy and more extensive grass ground cover.

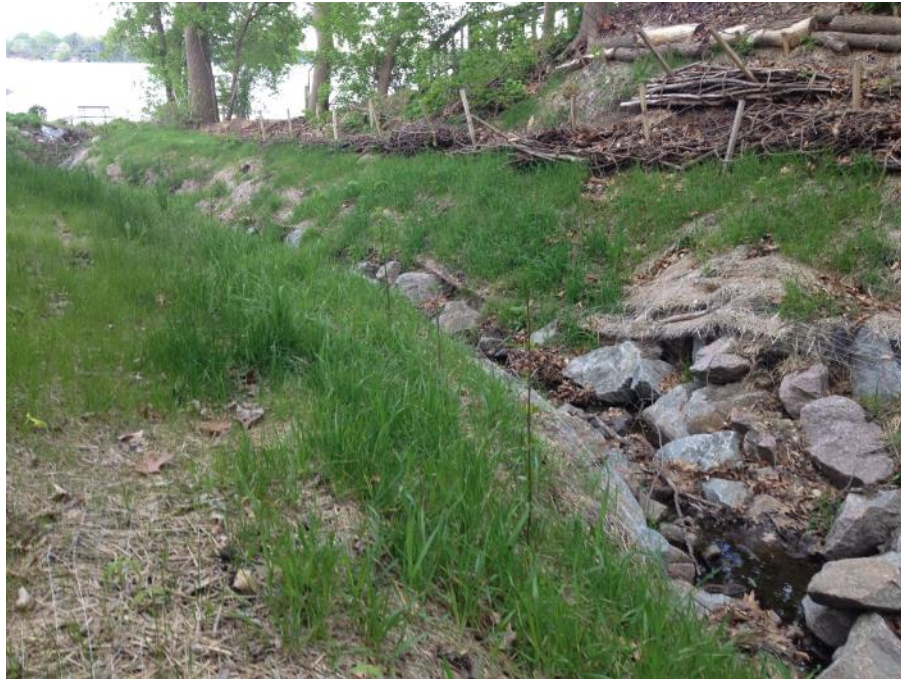
Figure 1: Vegetated Riprap Channel, 1 year after construction.

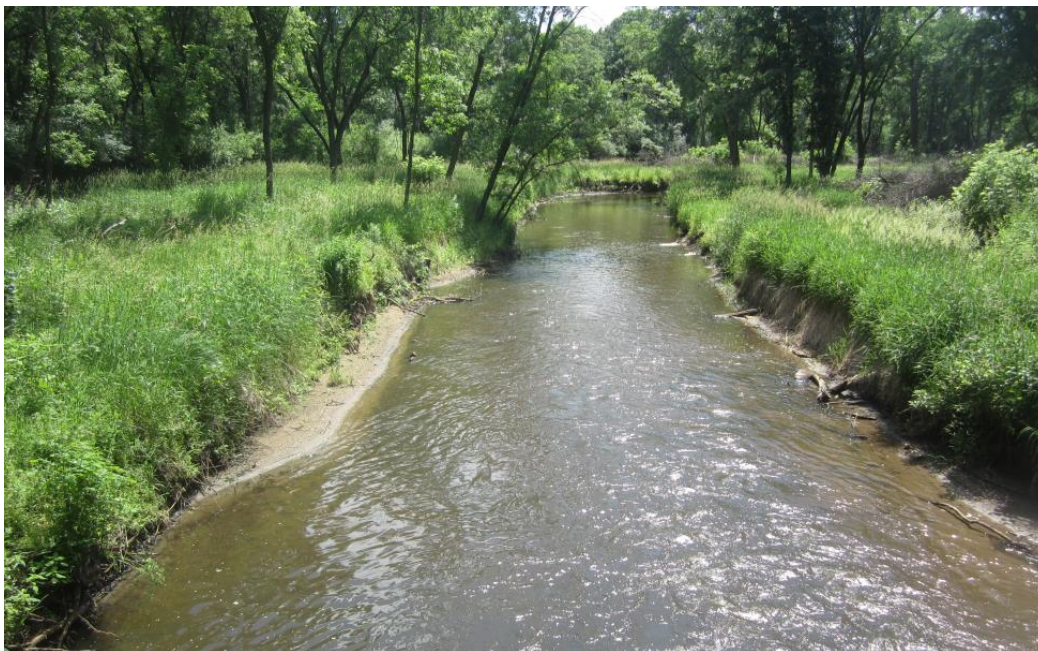
Figure 3: One year after clearing trees, the existing seed bank grew into a healthy grass buffer on Coon Creek

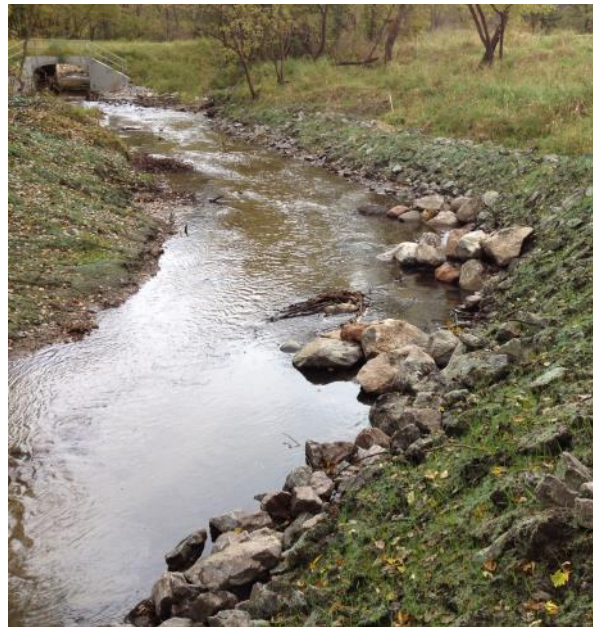
Figure 4: Three stream barbs to turn the flow of Purgatory Creek away from sharp outside bend.

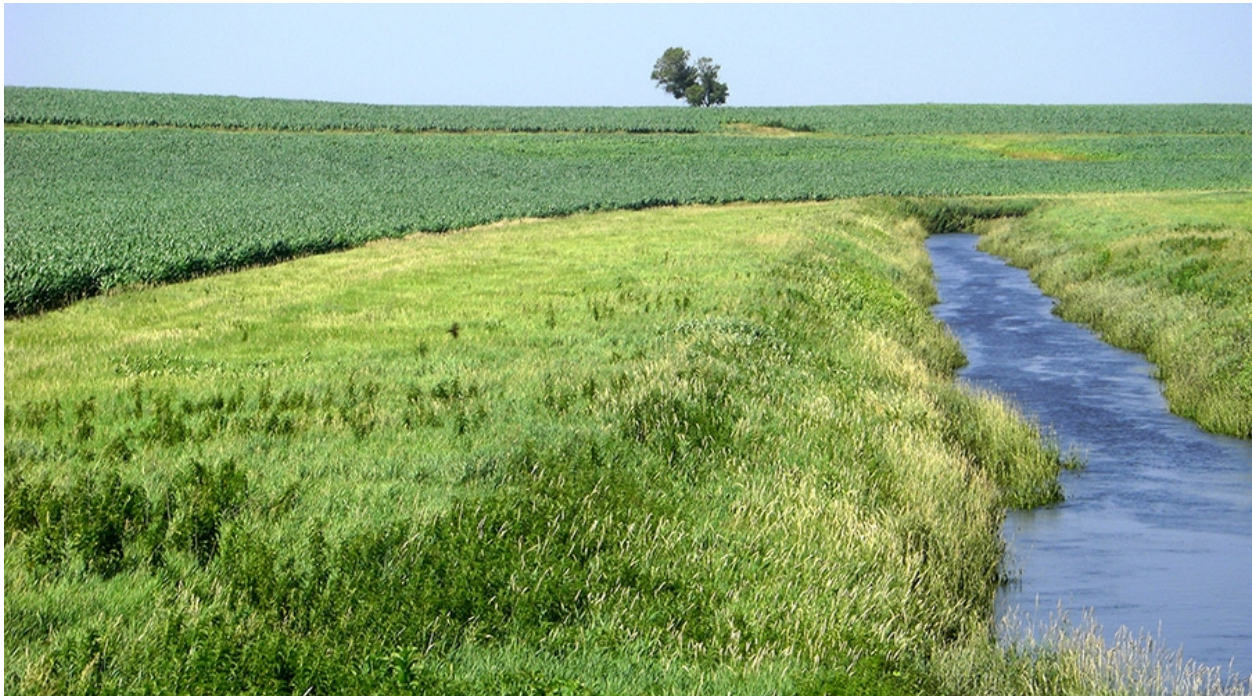
Figure 5: An established grassed buffer. Photo by MN DNR.

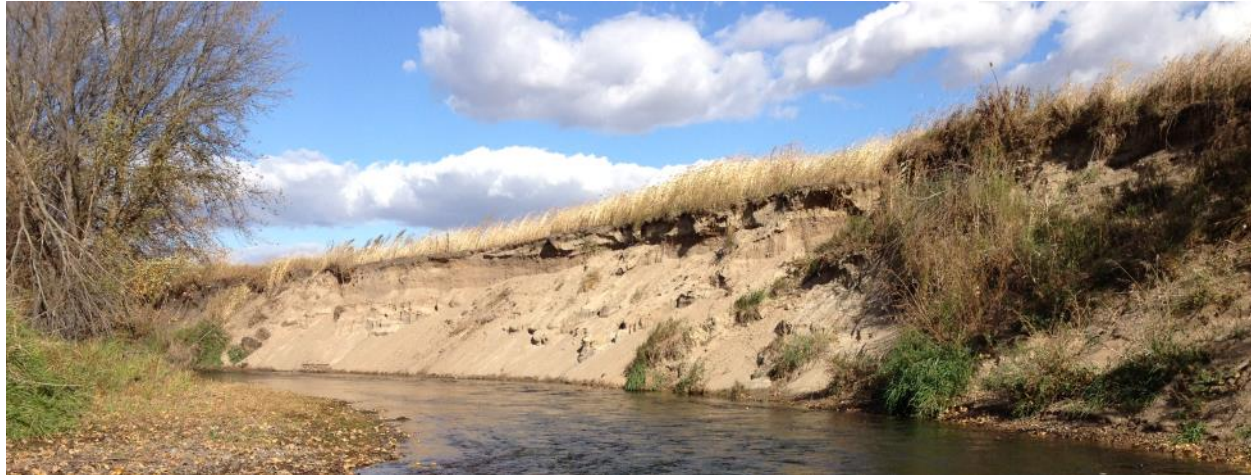
At erosion locations 11 – 16, river banks are severely eroding on the outside bends for approximately 1290 ft. and have an eroded vertical face from 4 - 12 ft. To stabilize the

erosion, banks will need to be regraded to a slope of 2:1 with the toe protected with vegetated riprap. If the landowner isn't willing to loose land for the 2:1 slope a steeper slope will need to be explored. In addition to the vegetated riprap, 26 stream barbs are proposed to redirect erosive force within the stream channel back toward the center of the channel and away from the banks. In order to mitigate the runoff coming off of the adjacent farm field upslope enforcement of the 1 rod buffer should also be invoked.

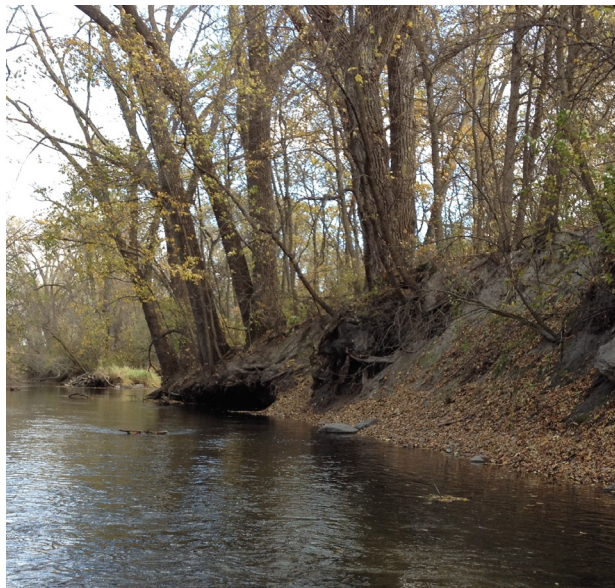
Lack of groundcover vegetation and eroding banks on erosion location 17.

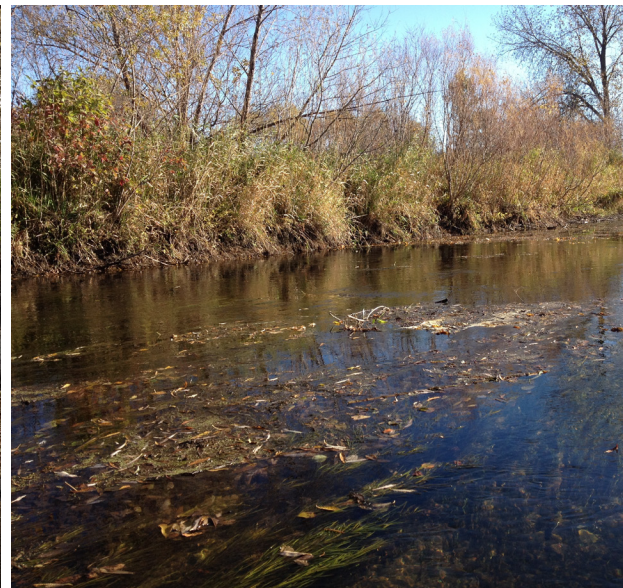
Downstream reach with less tree canopy and more extensive grass ground cover.

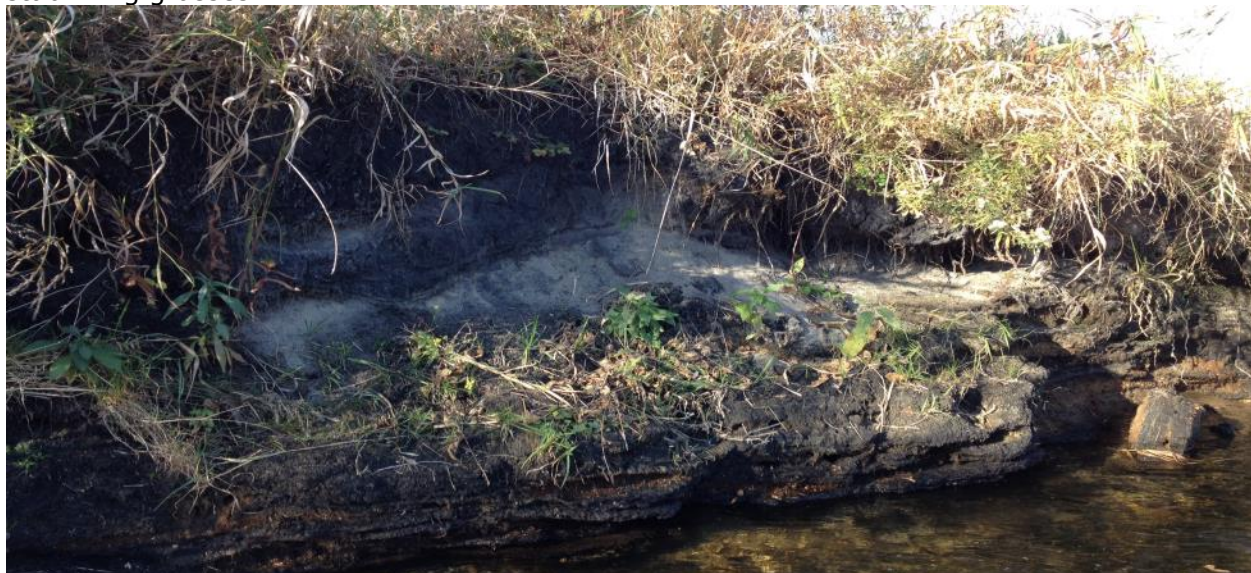
At erosion locations 18 - 22, river banks are moderately eroding on the outside bends for approximately 910 ft. and have an eroded vertical face of 4 ft. To minimize the current erosion, banks will need to be regraded to a slope of 2:1 with the toe protected with vegetated riprap. In order to accomplish the regrading and allow sunlight to penetrate the new grade trees will need to be removed directly upslope from the affected area for stabilizing grasses.

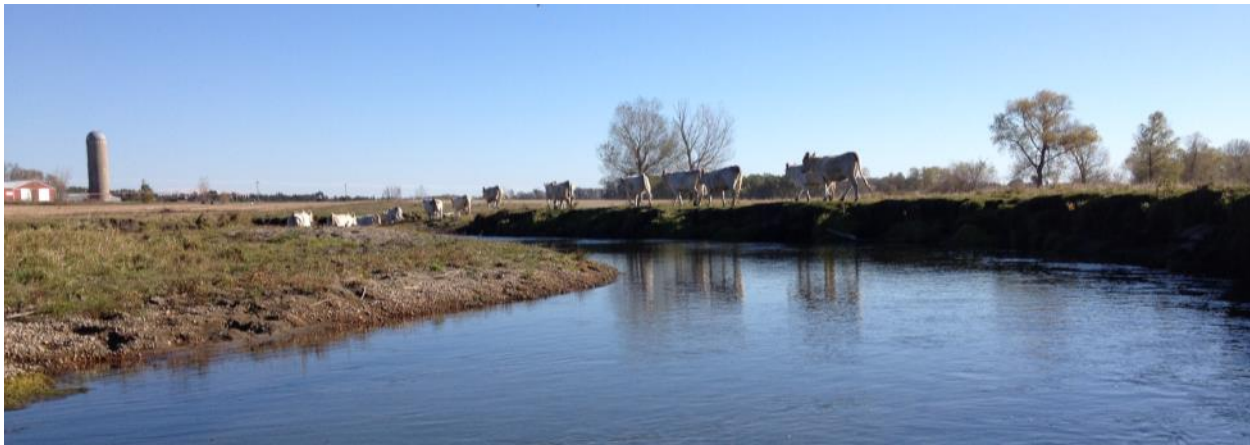
At erosion location 23, river banks are severely eroding for approximately 3400 ft. on both sides and have an eroded vertical face up to 3 ft. The erosion is due to do cattle watering and crossing the river. To minimize the current erosion, we recommend adding 2 specific

cattle crossing/watering points with reinforcement gravel on the property and installing exclusion fencing in all other areas along the river. Enforcement of the 1 rod buffer should also be invoked to increase the vegetation height and rooting depth of grasses to secure the river banks.
