Technical Memo

To: Margaret Johnson, Middle Fork Crow River Watershed District

From: Lucius Jonett, Wenck Associates, Inc.

Subject: Middle Fork Crow River Stream Bank Stabilization Projects

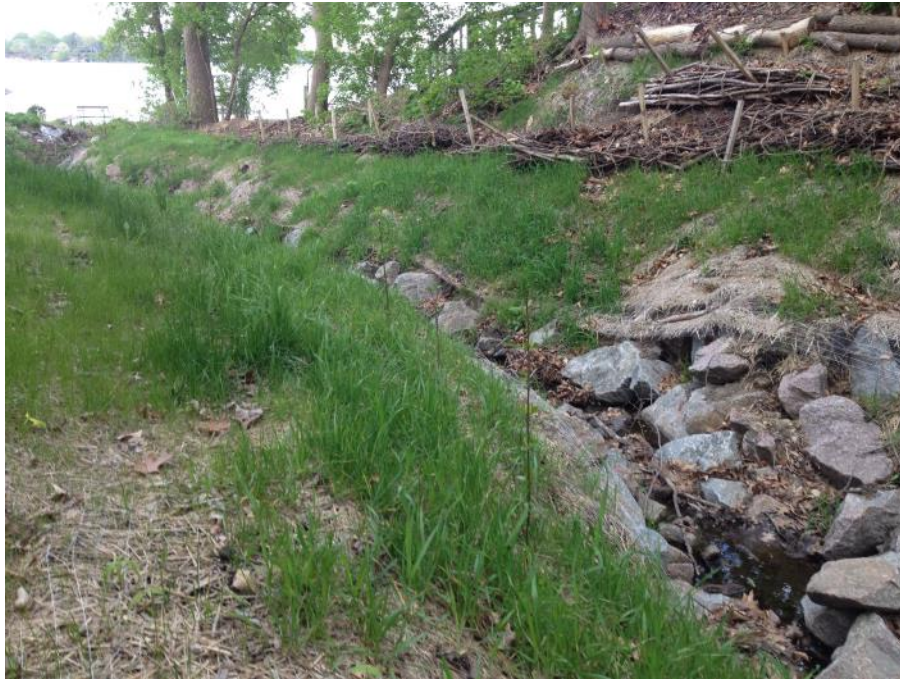
Figure 1: Vegetated Riprap Channel, 1 year after construction.

Vegetated riprap is a slope stabilization technique to be used in instances where flow velocity (5 – 20 CFS) requires hard armoring (rock) instead of bioengineered techniques. Vegetation adds a more natural aesthetic by camouflaging the rock.

Vegetated riprap is intended to provide toe protection on taller (> 4'), vertical, eroding stream banks. Riprap would be installed at the existing toe line of the side slopes and be keyed in slightly below the stream bed. Some bank disturbance would be required to make the vertical bank less steep (ideally, 2:1 H:V or less) by grading from the top of the bank to the new riprap toe. Final stabilization of the riprap toe areas would include revegetation with native seed and either erosion control blanket along the channel where high flows are expected and straw mulch or hydro-mulch in the upland areas. Riprap toe would follow the existing bank, would balance cut and fill on site and would not alter the channel cross section.

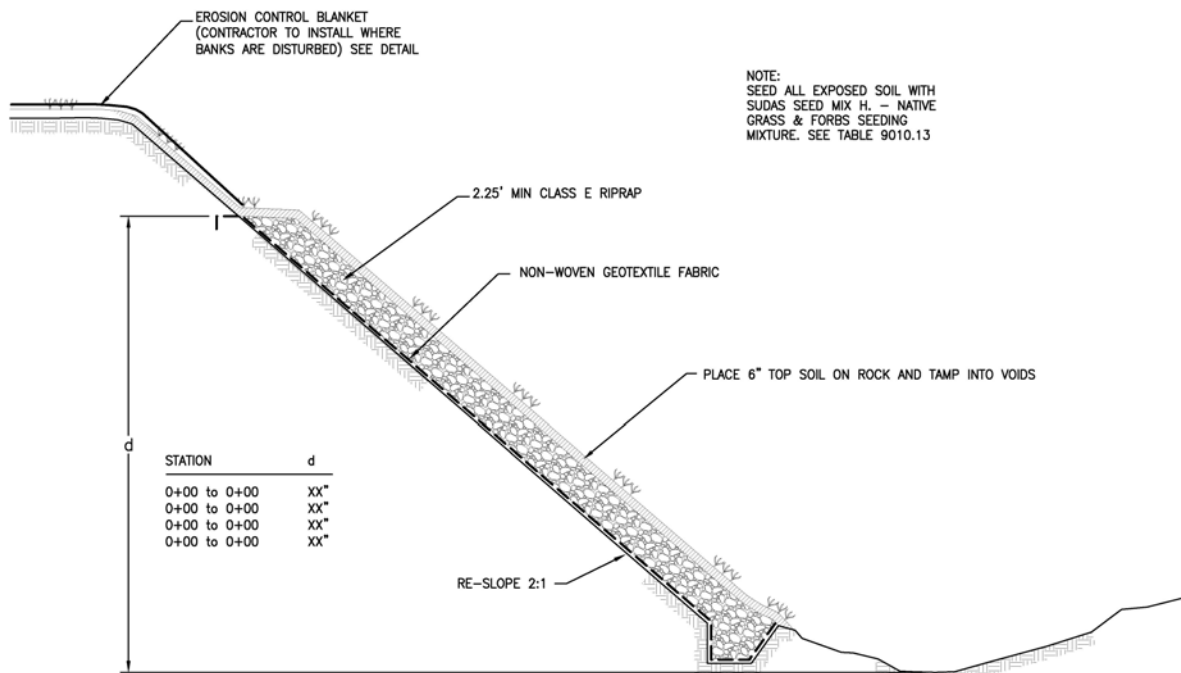
1
 D-101

VEGETATED RIPRAP DETAIL
 NOT TO SCALE

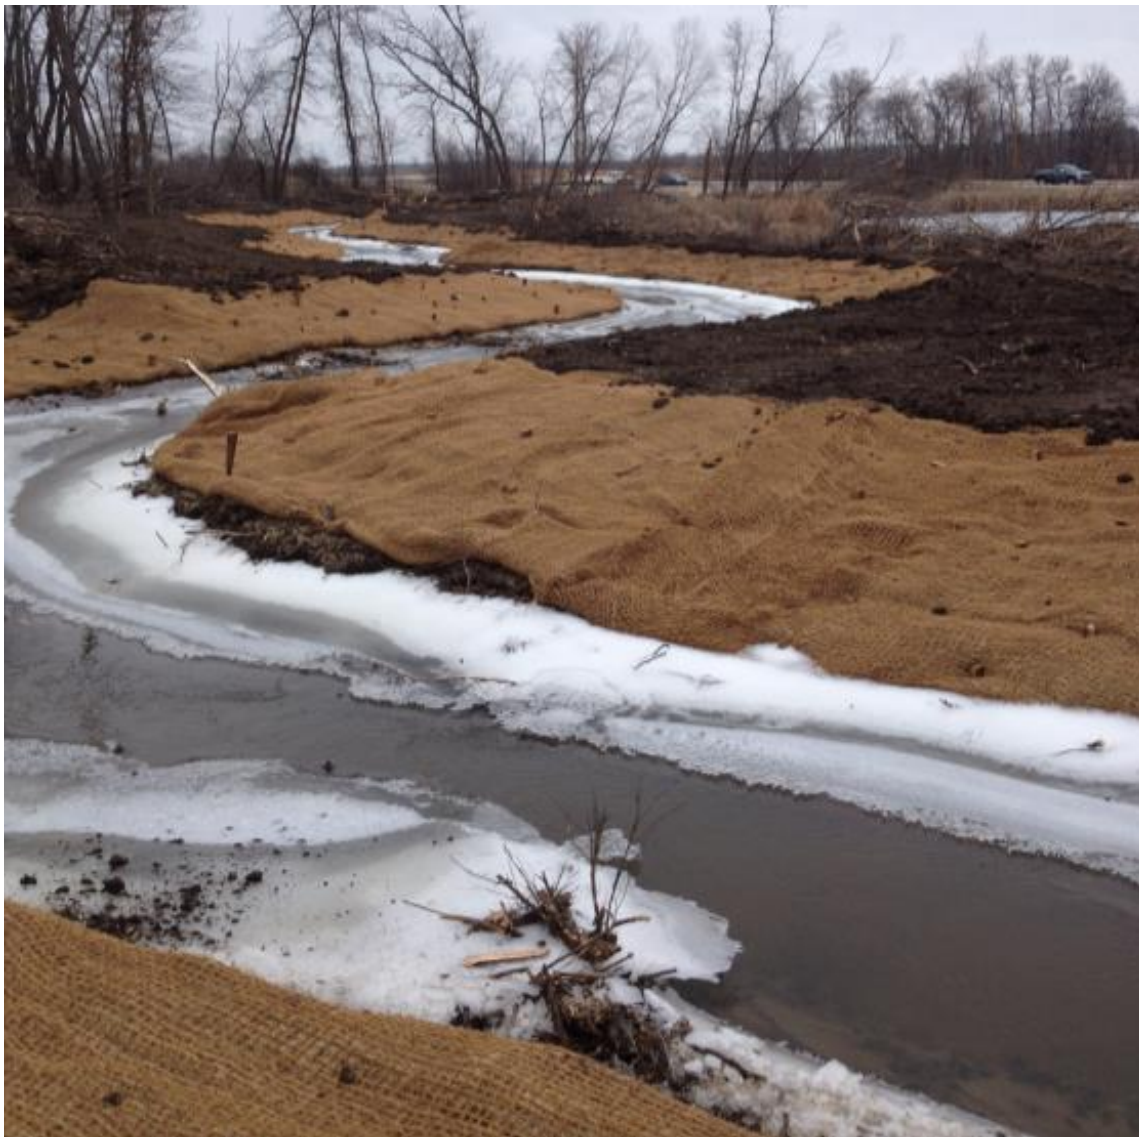
Figure 2: Resloped Banks Constructed During Winter Work on Elm Creek.

Bank resloping is a bioengineering stabilization technique to be used in instances where flow velocity allows (<6 CFS) and/or for the portions of the bank above the normal high water level of a channel. Bank resloping is intended to establish native vegetation and provide toe protection on shorter (<3'), steep stream banks. Resloping the bank ranges from 3:1 (H:V) or less (preferred), to no steeper than 2:1. It is intended to provide a stable slope for new vegetation to establish. The roots of the vegetation hold the slope during periods of inundation and reduce soil migration.

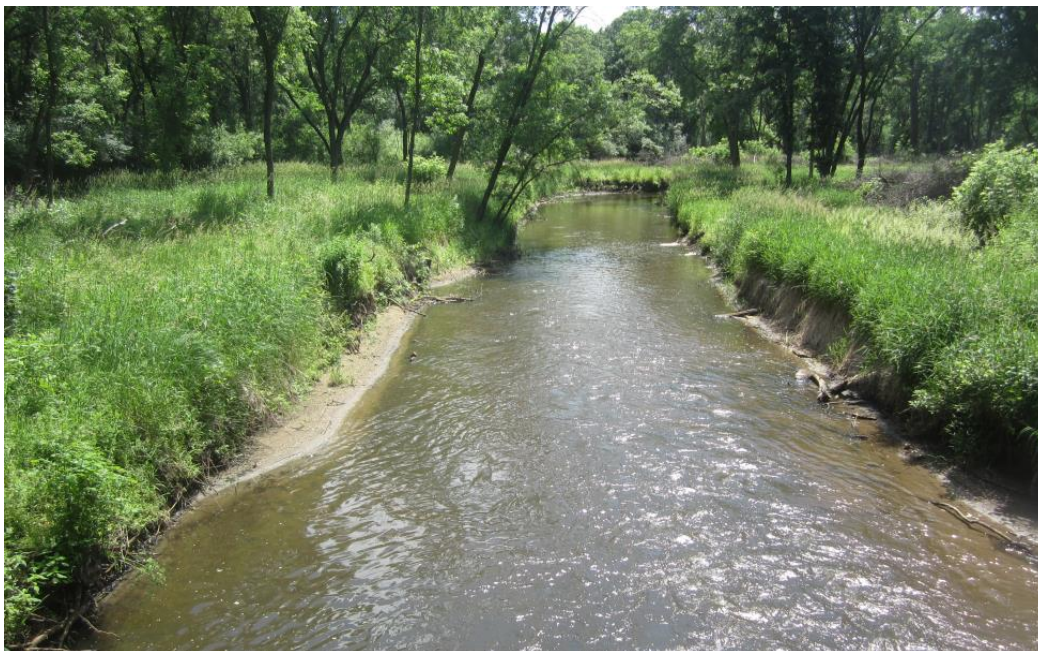
Figure 3: One year after clearing trees, the existing seed bank grew into a healthy grass buffer on Coon Creek

Thinning existing trees to presettlement vegetation densities of 5 – 10 trees per acres, allows for more sunlight to reach the soil. Increased sunlight encourages the amount and vigor of ground plane grasses thus mitigating soil movement into adjacent waterbody's.

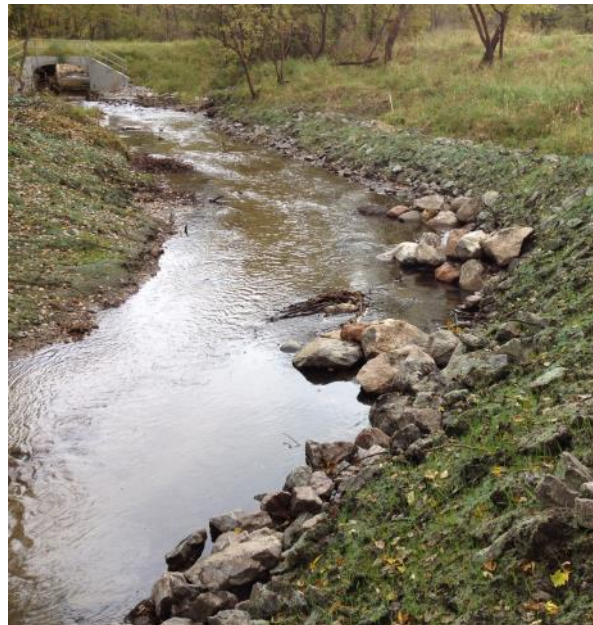
Figure 4: Three stream barbs to turn the flow of Purgatory Creek away from sharp outside bend.

Stream barbs are a descending trapezoidal mass of rock, pointed upstream extending from the center of the channel back into the adjacent bank. Stream barbs serve to redirect erosive force within the stream channel back toward the center of the channel and away from the banks. On the downstream side, at approximately 5 times the length of the barb, water flow experiences reduced velocity and erosive action allowing sedimentation to occur.

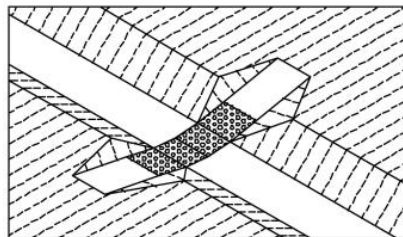
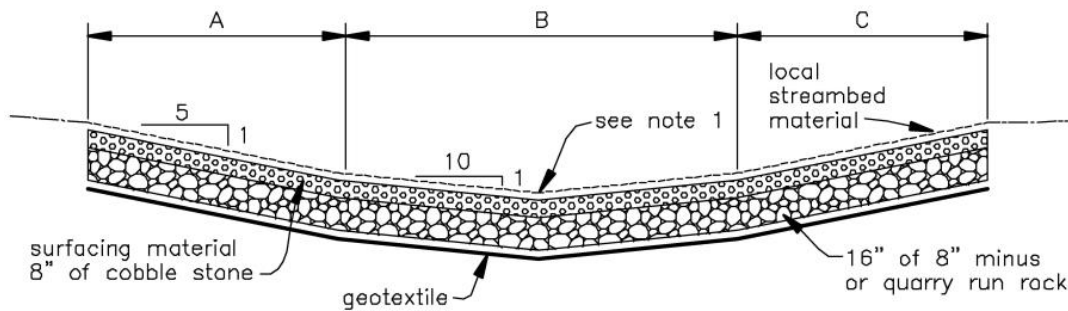
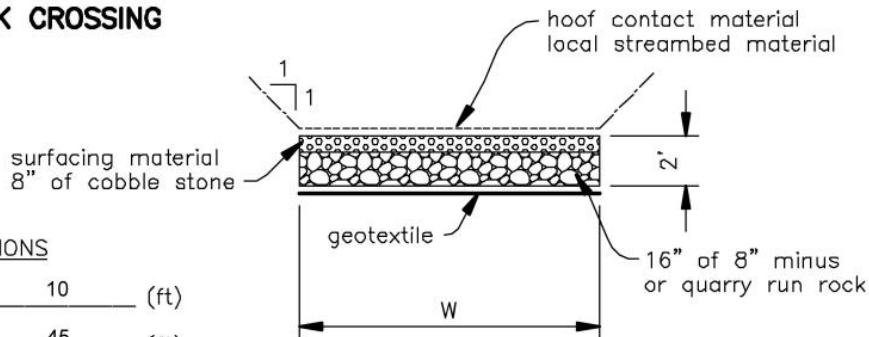
LIVESTOCK CROSSING

Cattle crossing and exclusion fencing serves to prevent the overgrazing of bank vegetation and trampling of stream banks while still allowing livestock access to water and pastures on the opposite side. Disturbance and erosion of the stream bed and banks is minimized by only allowing access and crossing of the stream in select locations that have been designed and constructed to be stable under cattle and equipment traffic.

1. Crossing surface shall be a minimum of 0.2 ft below channel invert.
2. Surfacing material shall be compacted as per method (4) of CS-15.6.

A = 10 (ft)

B = 45 (ft)

C = 10 (ft)

W = 15 (ft)

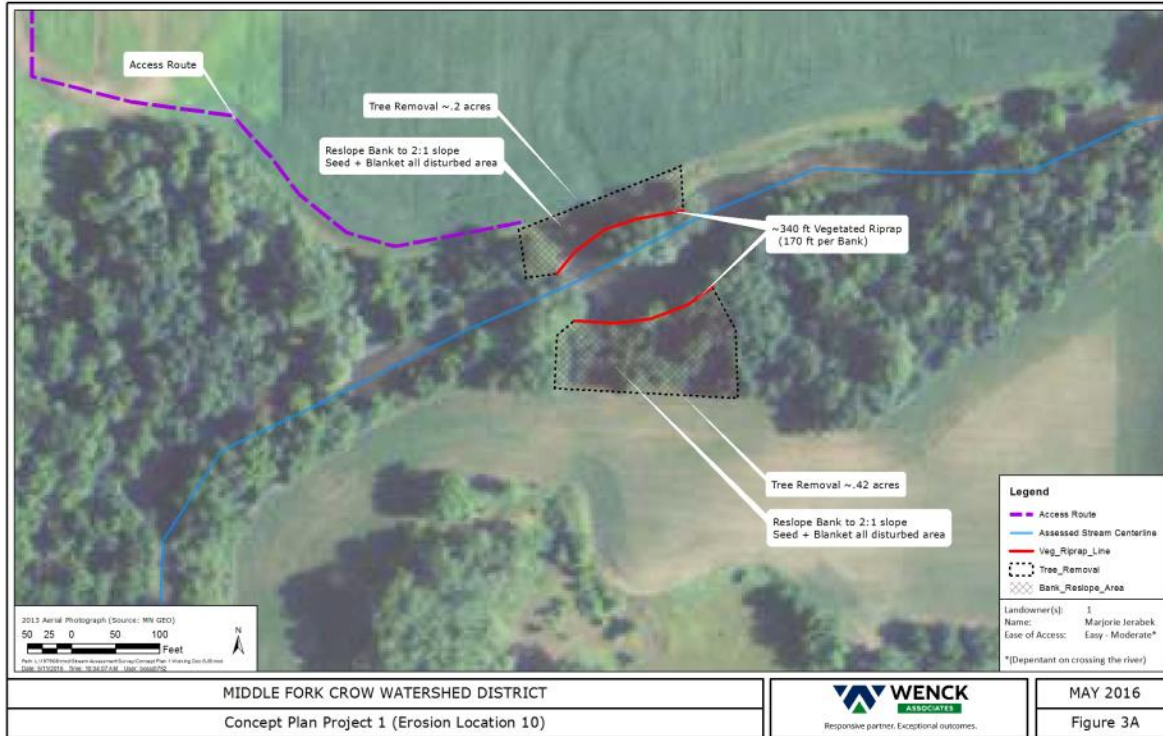
Concept Plan 1 (Figure 3A)

At erosion location 10, river banks are severely eroding for approximately 170 ft. on both sides and have an eroded vertical face of 4 ft. The erosion is due to do a bridge located directly upstream that creates a restriction in flow, a hydraulic jump and circulating eddies coming off the downstream flow onto the embankments. To minimize the current scour, collapse and erosion, both banks will need the toe protected in with vegetated riprap and regraded to a slope of 2:1 (3:1 if possible). In order to accomplish the regrading and allow sunlight to penetrate the new grade trees will need to be removed directly upslope from the affected area.

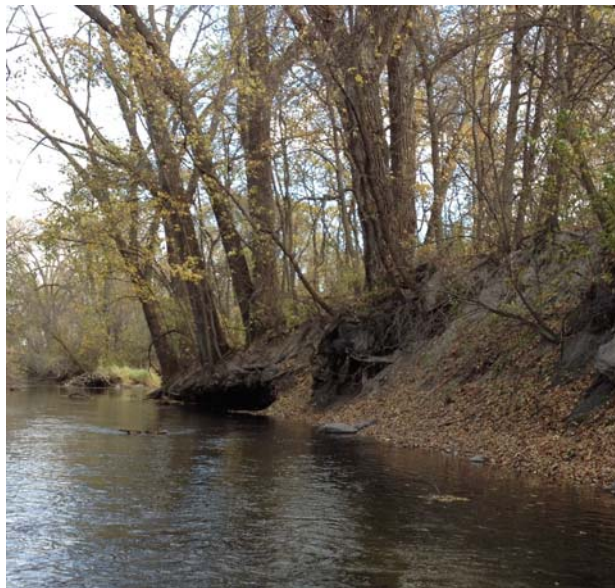
Lack of groundcover vegetation and eroding banks on erosion location 17.

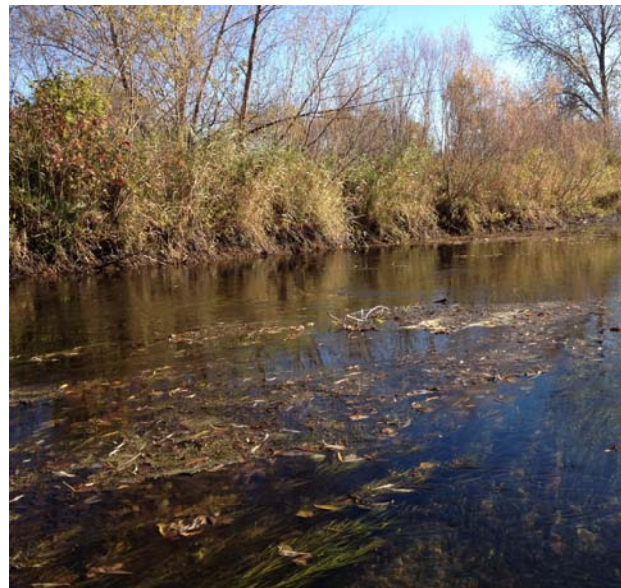
Downstream reach with less tree canopy and more extensive grass ground cover.

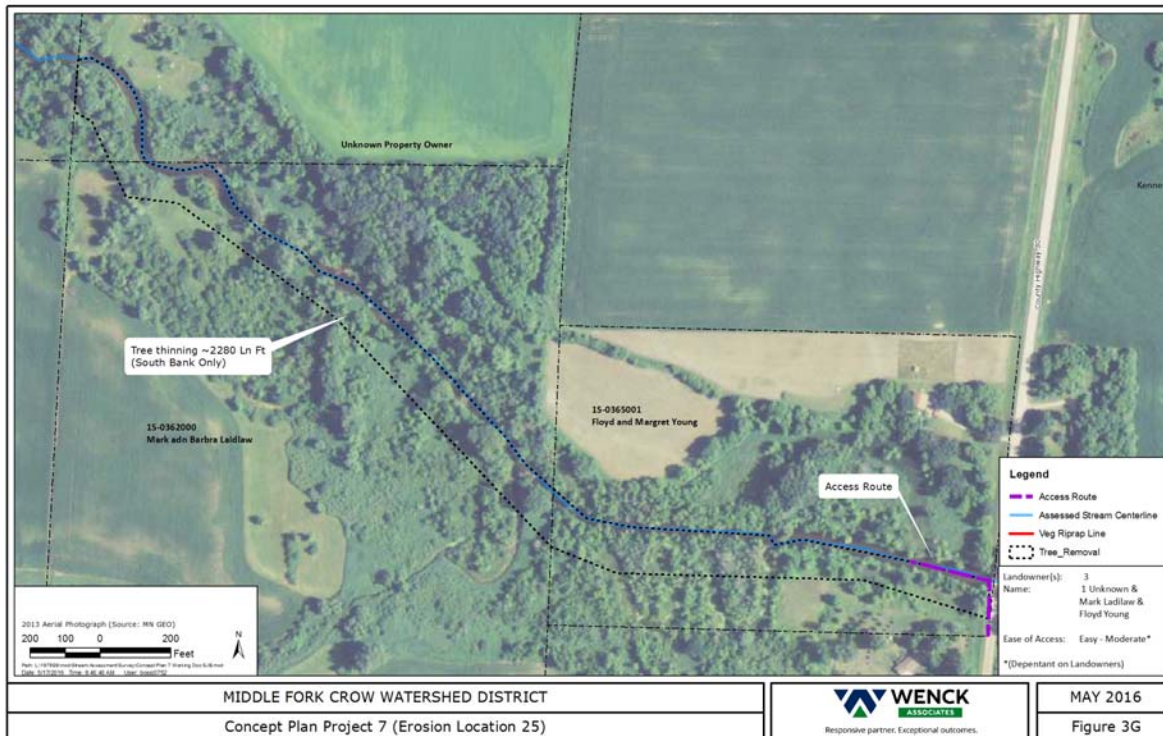
Concept Plan 7 (Figure 3G)

At erosion locations 25, the river has been straightened and the channel is over-widened, incised or confined by flood and spoil deposition on the banks. River banks are moderately eroding for approximately 8600 ft. while the channel runs through the floodplain forest. To minimize the current erosion, the existing tree canopy should be thinned on the southern bank to allow sunlight to penetrate the areas on both banks for stabilizing grasses to germinate and grow. This project could be accomplished by a crew of Conservation Corps employees over approximately a four week period.

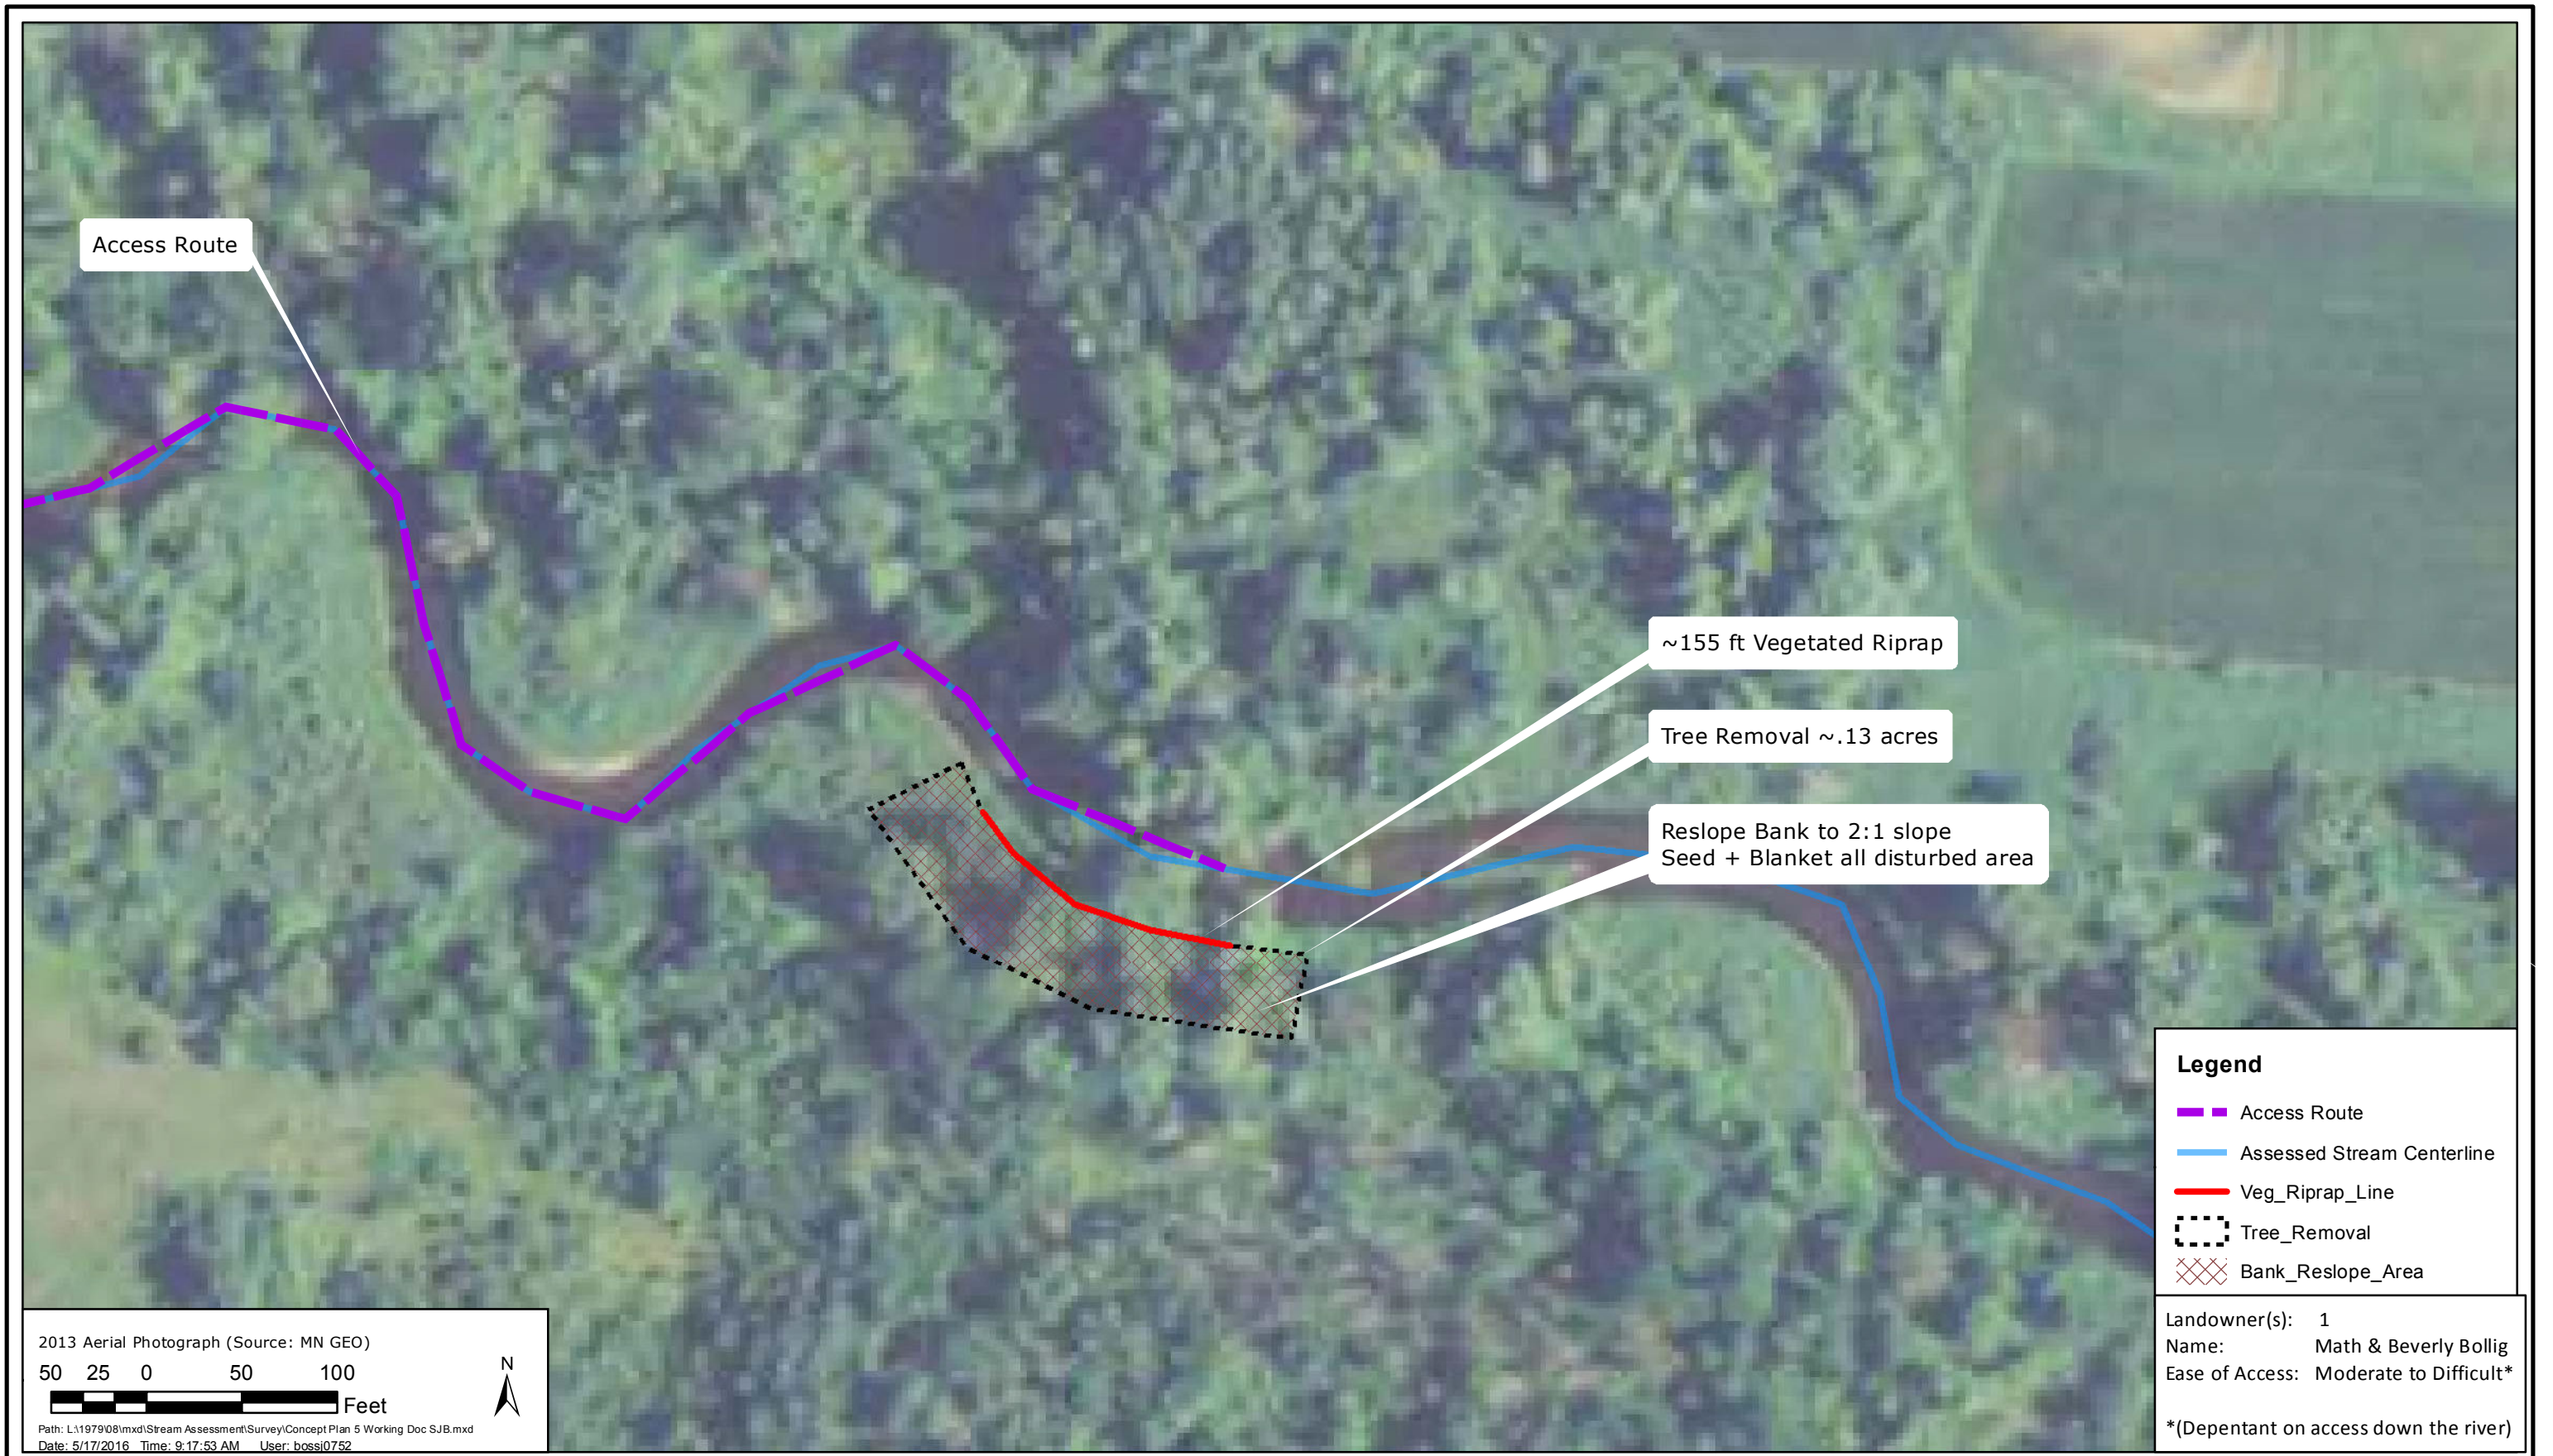
MAY 2016
 Figure 3F

MIDDLE FORK CROW WATERSHED DISTRICT
 Concept Plan Project 6 (Erosion Location 24)

Concept Plan 6 (Figure 3F)

At erosion location 24, river bank is moderately eroding on the outside bend for approximately 155 ft. and have an eroded vertical face of 4 ft. To minimize the current erosion, banks will need the toe protected with vegetated riprap. In order to allow sunlight to penetrate, trees will need to be removed directly upslope from the affected area for stabilizing grasses to germinate and grow.

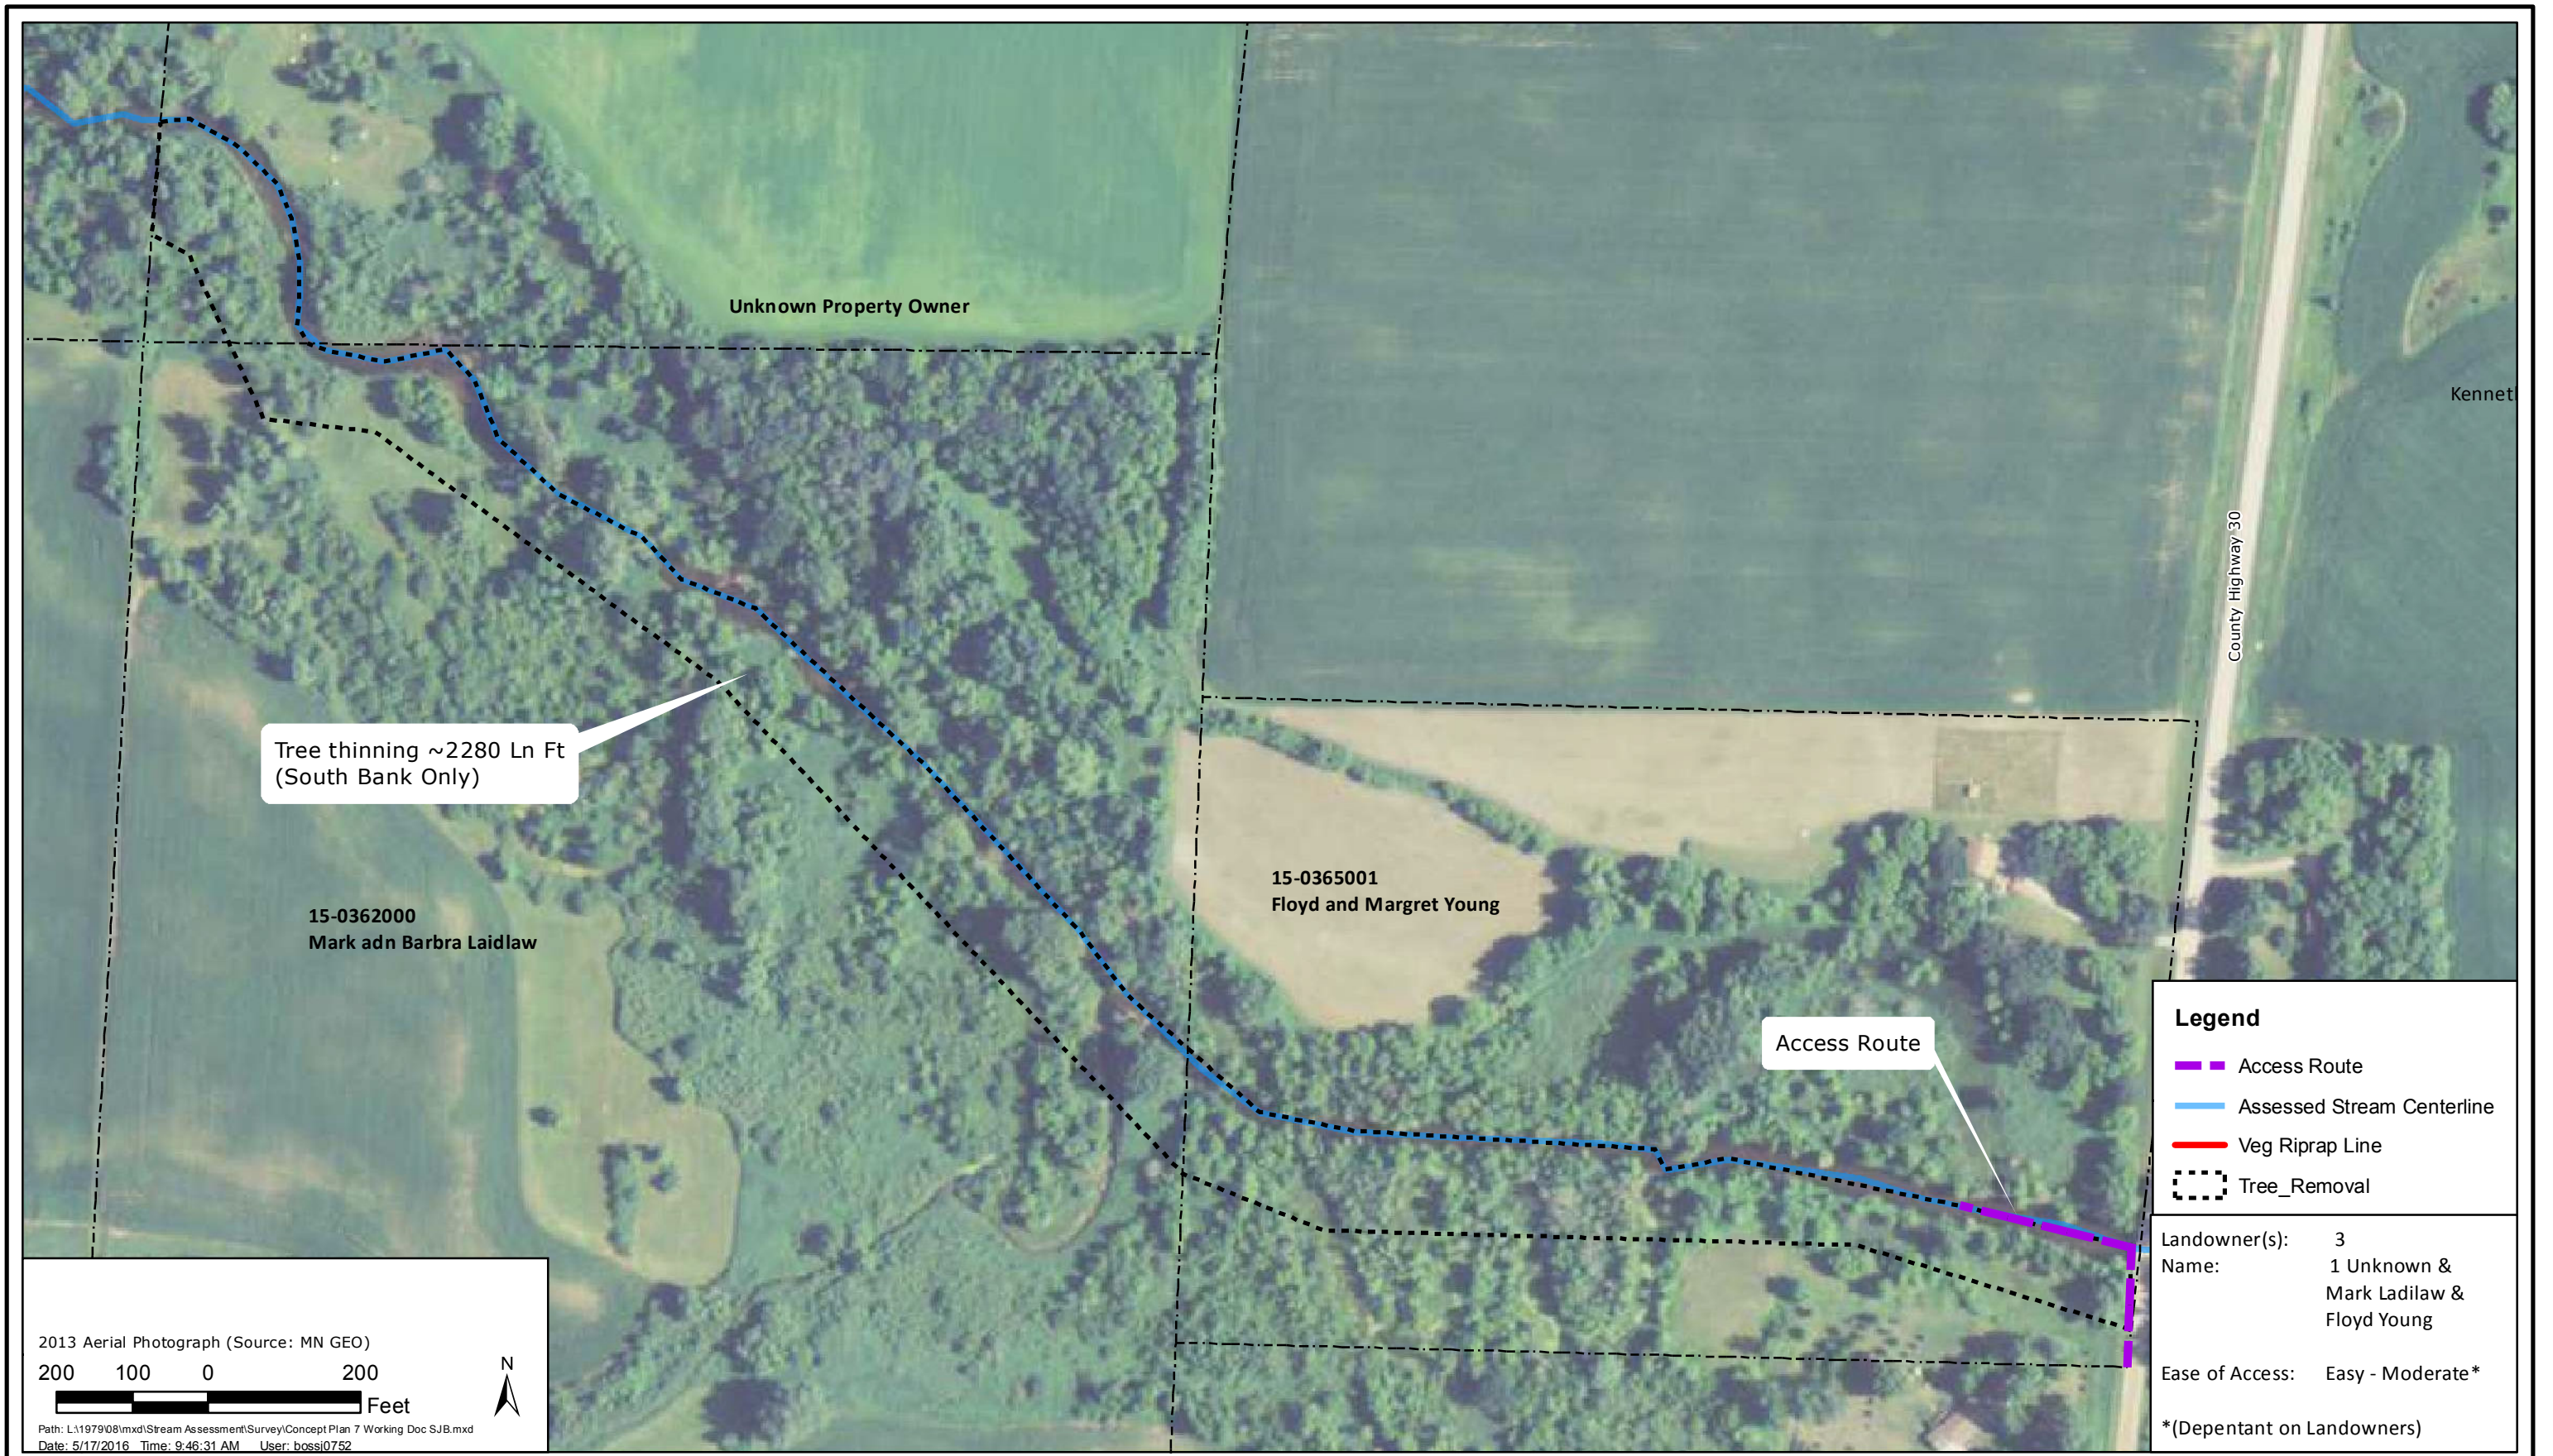
MAY 2016
Figure 3G

MIDDLE FORK CROW WATERSHED DISTRICT
Concept Plan Project 7 (Erosion Location 25)
