Water Quality Data Hubbard, Schultz, Wheeler Shallow Chain of Lakes

Water Quality Data

Hubbard, Schultz, Wheeler Shallow Chain of Lakes

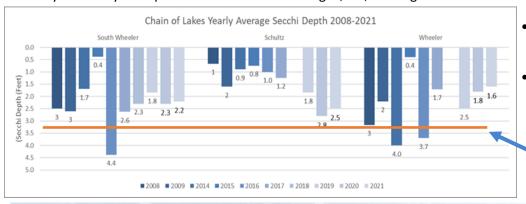
Secchi disk measurements over time can give a general indication of issues in a lake by assessing the water clarity, or turbidity. Turbidity is suspended materials such as algae, silt, and organic matter in the water.

- The 0.00 is the surface of the water body.
- Deeper secchi disk readings (larger numbers) indicate clearer water.

3.28 ft (1 m) = MPCA Shallow Lake Ecoregion Average for North Central Hardwood Forest

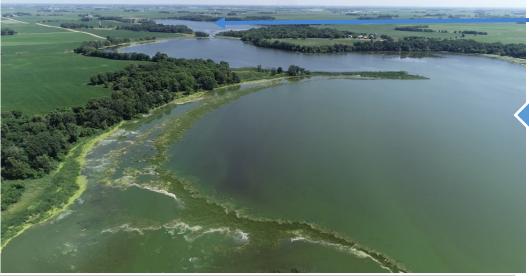
Chain of Lake Yearly Average Total Suspended Solids 2008-2021

A measure of the material suspended in water. Total suspended solids (TSS) cause: a) interference with light penetration, b) buildup of sediment and c) potential reduction in aquatic habitat. Solids also carry nutrients that cause algal blooms and other toxic pollutants that are harmful to fish.

30 mg/L TSS =MPCA Shallow Lake Ecoregion Average for North Central Hardwood Forest

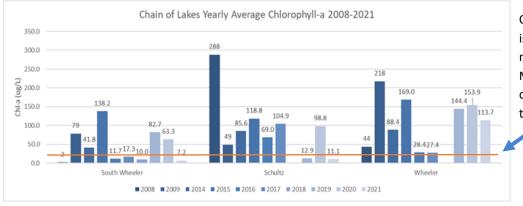
Chlorophyll-a – Chlorophyll-a is the pigment in plants that make them look green.

Measuring chlorophyll-a indicates the amount of algae in the water column.

20 µg/L = MPCA Shallow Lake Ecoregion Average for North Central Hardwood Forest

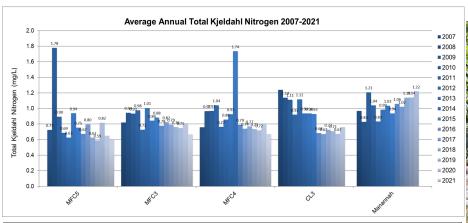
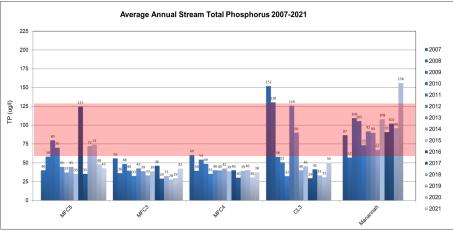
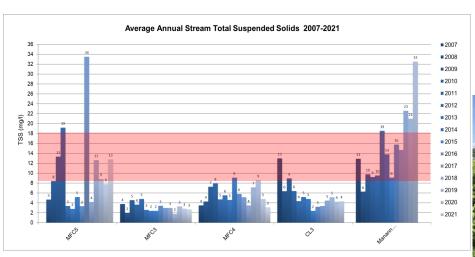
Streams Monitoring

To the left you will see three graphs one for Total Kjedahl Nitrogen, Total Phosphorus, and Total Suspended Solids. The Red boxes on the graphs indicate the typical measurements one might find based on the North Central Hardwood Forest Ecoregion for streams. Total Kjeidahl Nitrogen does not have established typical values. One thing to note is that the Manannah stream site is event based monitoring. So values at Manannah are higher than monthly sampling.

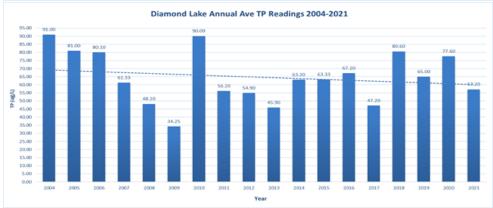
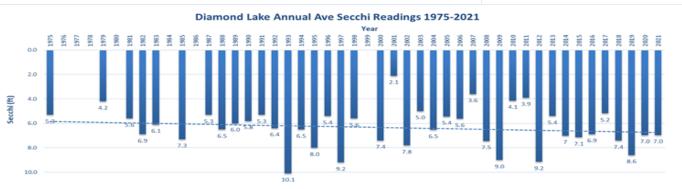
Diamond Lake trends for total phosphorus (TP), Chlorophyll-a (Chl-a), and Secchi have all been showing consistent improvement when looking at the trend lines. Total Suspended Solids (TSS) has remained relatively consistent over the last 16 years. In 2019 the first successful drawdown of the Hubbard, Schultz, Wheeler chain of lakes was completed. This will hopefully have a further positive effect on Diamond lake. This along with many other projects completed around Diamond Lake and its surround watershed should continue to help improve water quality.

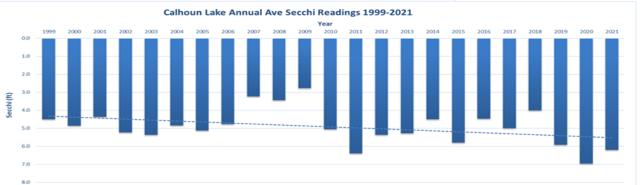
Calhoun is showing improving water quality values over the last 15 years. There has been some improvement when looking at trends for Total Phosphorus (TP), Chlorophyll-A (Chl-a), clarity (secchi) and total suspended solids (TSS). Calhoun is suitable for swimming and wading with good clarity and low algae levels throughout the open water season. Being in the North Central Hardwood Forest Ecoregion Calhoun has been predominately located within the eutrophic zone but is trending towards more of a mesotrophic state. 2021 was a very dry year which makes the results form the 2021 monitoring season hard to interpret. We will continue to monitor long term trends

and watch for any evidence shat points to declining water quality.

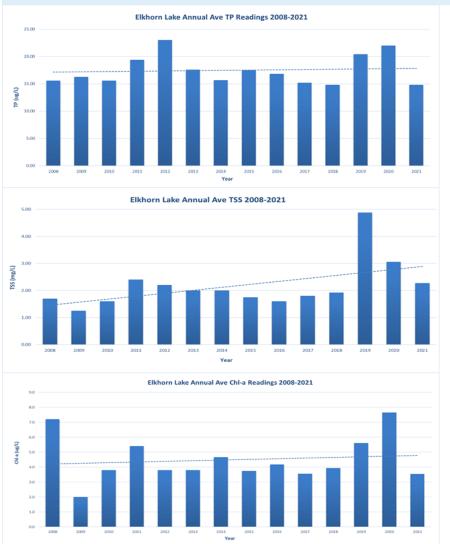
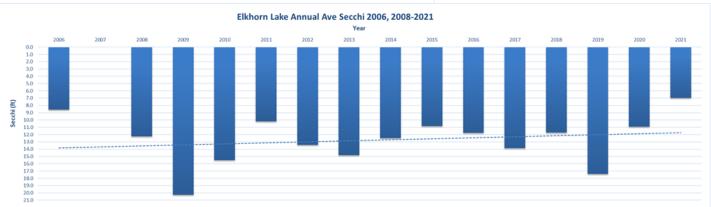
Elkhorn Lake

Elkhorn is showing a decline in water quality looking at the 14 year trend line. In 2019 and 2020 there was a spike in TP, TSS, and Chl-a. This did have a noticeable impact on the historical trend. The watershed did conduct a study with Wenck Associates. This study looked at lake hydrology and the replacement of the dam on Elkhorn. With a relatively small contributing watershed efforts taken withing the immediate are to protect water quality are likely to have a bigger impact that waterbodies with a larger contributing watershed. Elkhorn has been situated predominately in the Mesotrophic zone for water quality. We will be watching for any confirming data that shows a trend towards more of a eutrophic state.

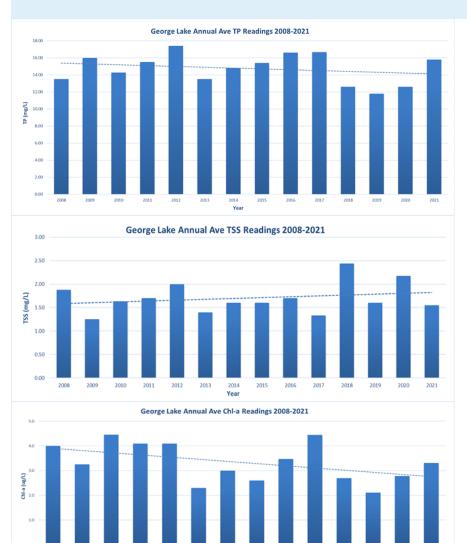
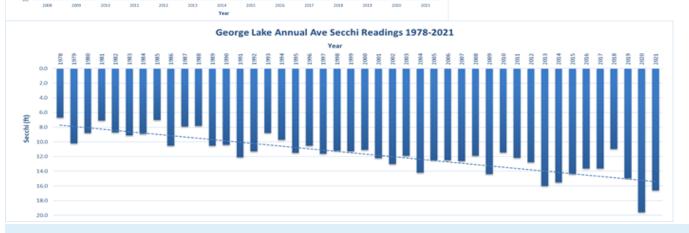
George Lake has shown improvement in most water quality parameters. Although, Total Suspended Solids (TSS) has a slight up trend. This is primarily due to high readings in 2018 and 2020. Secchi readings have continually improved since 1978 which is quite impressive. But again, you can see 2018 as an outlier since it was a very wet summer with multiple big rain events. 2021 was an abnormal year with very little rain. This makes 2021 hard to interpret within the overall picture of water quality in George Lake. We will continue to monitor George Lake for any divergence from the current trends of the lake.

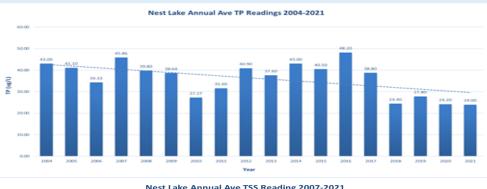
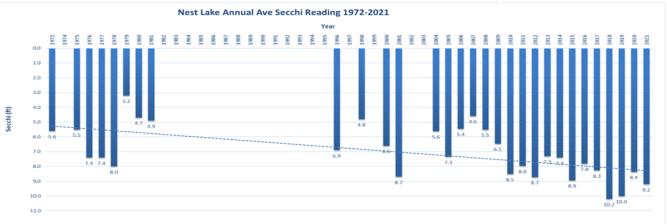
Nest Lake

${f N}$ est Lake water quality parameters have shown improvement since 2004. Especially total phosphorus (TP) and total suspended solids (TSS). Chlorophyll-a has remained fairly consistent over the years. The District is currently working on a study that looks at legacy phosphorus with in the Nest lake sediments. One component of this is taking dissolved oxygen profiles. This data will help us determine next steps to address legacy phosphorus that persists in the sediments at the bottom of the lake.

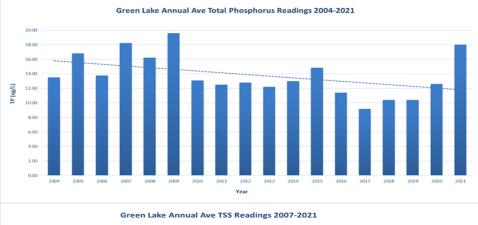
Green Lake

Green Lake, has seen a nice overall trend towards better water quality since 2004. Total Suspended Solids (TSS) had high results in 2018 and 2021. Both years were outliers with regards to precipitation. The introduction of Zebra muscles and the drought in 2021 does make it harder to interpret the data but we will continue to monitor the waters to see what the long term trends are. We have also begun taking profile measurements but it will take a few years of data do draw any conclusions. Green lake's trophic state is on the boarder between oligotrophic and mesotrophic which is confirmed by its lack of algal blooms and limited nutrients.

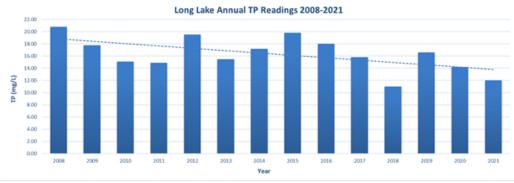
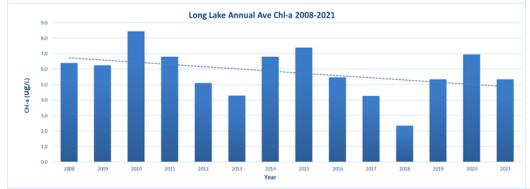
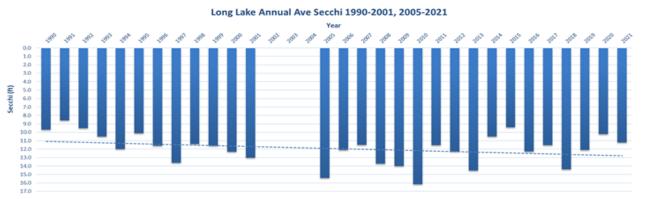
Long Lake, has seen a nice overall trend with improving water quality parameters. total phosphorus, chlorophyll -a, Secchi, and total suspended solids have all shown improvement since 2008. This is a relatively small data set so we will continue to monitor Long and watch for any changes that might point to a change in water quality. At the end of this document you will find Trophic State Index (TSI) for lakes within the Middle Fork Watershed and will see that Long Lake is doing well and staying within the mesotrophic TSI range.

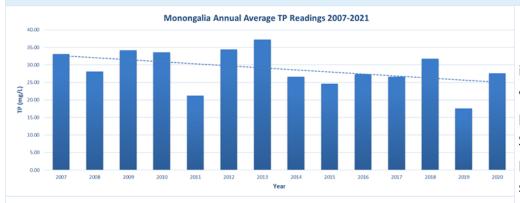
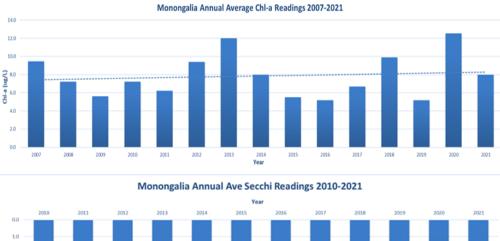
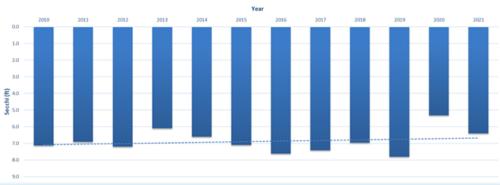
Monongalia, has shown improving water quality when looking at total phosphorus, Chlorophyll-a and Secchi readings. Total suspended solids have shown a slight uptrend but part of that increase is largely due to the very wet year in 2007 which drove run off and resulted in higher than normal sediment entering waters. We will continue to monitor Monongalia for any changes in water quality.

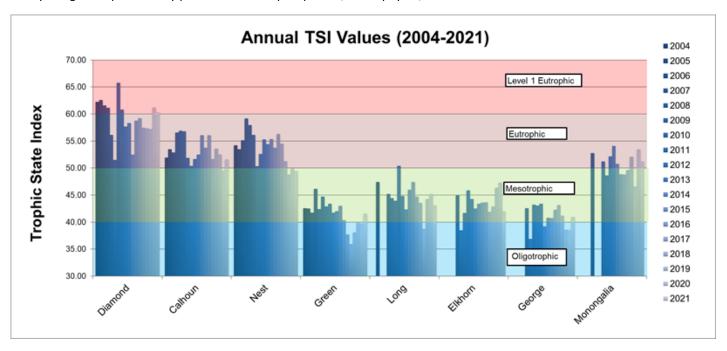
To determine the overall health of a lake one can look at Carlson's Trophic State Index (TSI). Trophic state indicates the overall productivity, or plant and algae growth, occurring in a lake. The TSI uses algal biomass as its basis and is determined by using three productivity parameters: total phosphorus, chlorophyll-a, and secchi disk.

When looking at the above data one can see that the lakes have been fairly consistent since 2004 with a slight improvement in TSI values. We are making lower lows and lower highs as you look at each individual lake.

TSI 30-40 Oligotrophic – clear water, hypolimnion oxygenated throughout the year (except in shallow lakes)

TSI 40-50 Mesotrophic – Water moderately clear, but anoxia becoming more likely in hypolimnion during the summer

TSI 50-60 Lower Boundary of classical eutrophy: Decreased transparency, anoxic hypolimnia during the summer, aquatic plant problems evident, warm water fisheries only.

TSI 60-70 Eutrophic: Dominance of blue-green algae, algal scums probable, extensive aquatic plant problems

TSI 70-80 Hypereutrophic: Heavy algal blooms possible throughout the summer, dense aquatic plant beds, but extent limited by light penetration.
